HS-802-103

PROOF PRESSURE EVALUATION OF WORN PASSENGER CAR TIRE CARCASSES

S. K. Clark
R. N. Dodge
D. W. Lee
J. R. Luchini

FINAL REPORT

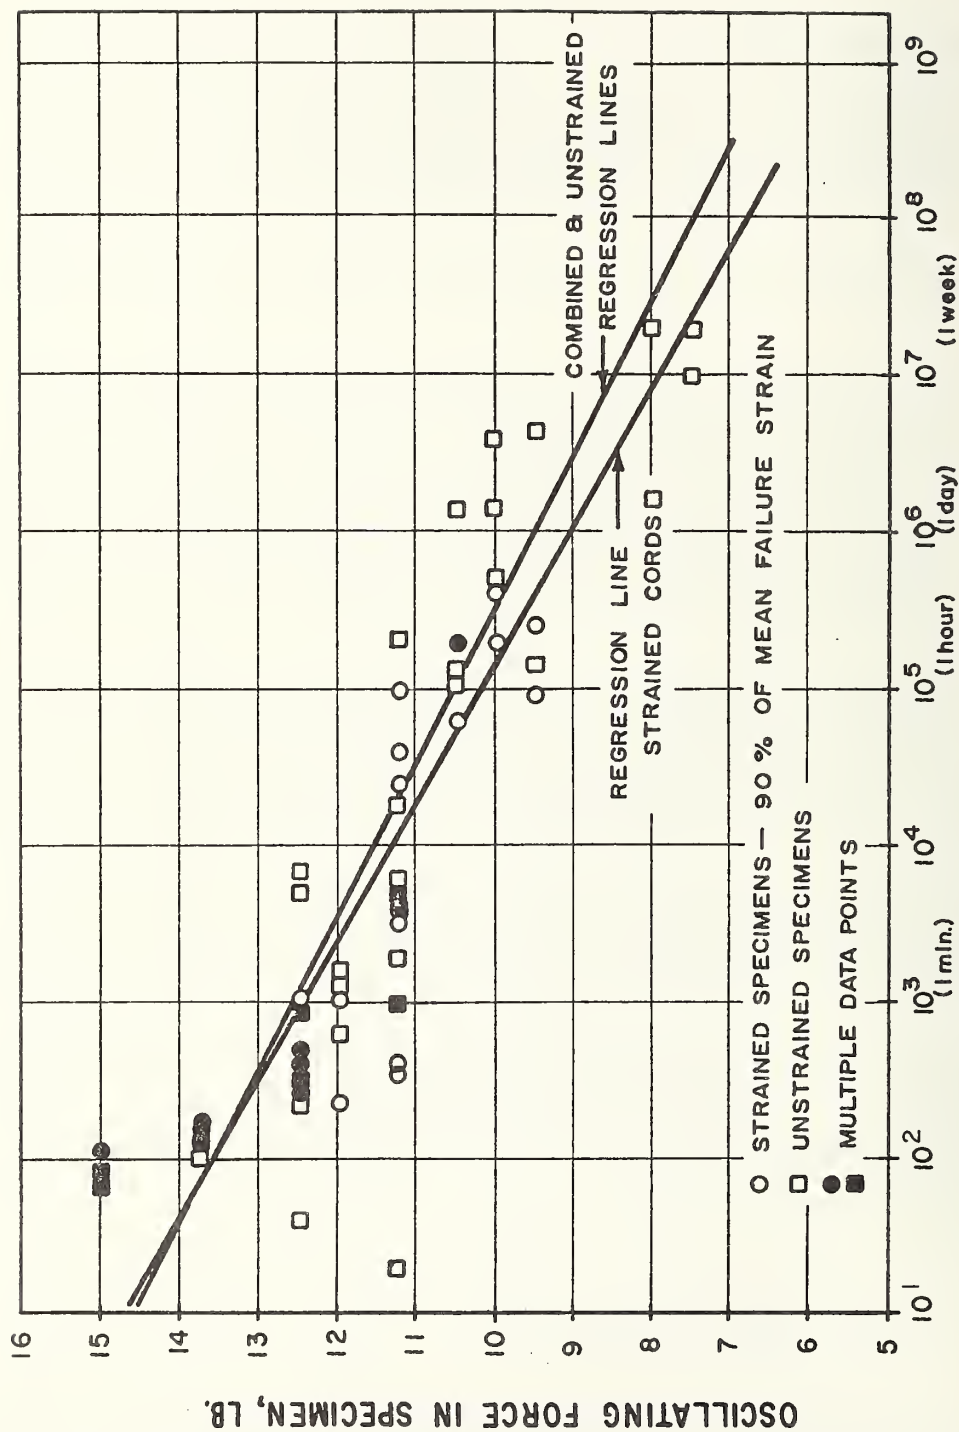
FIGURE 2. CYCLES TO FAILURE VS. OSCILLATING FORCE LEVEL FOR DIPPED NYLON CORD

The data obtained is shown in Figure 2.

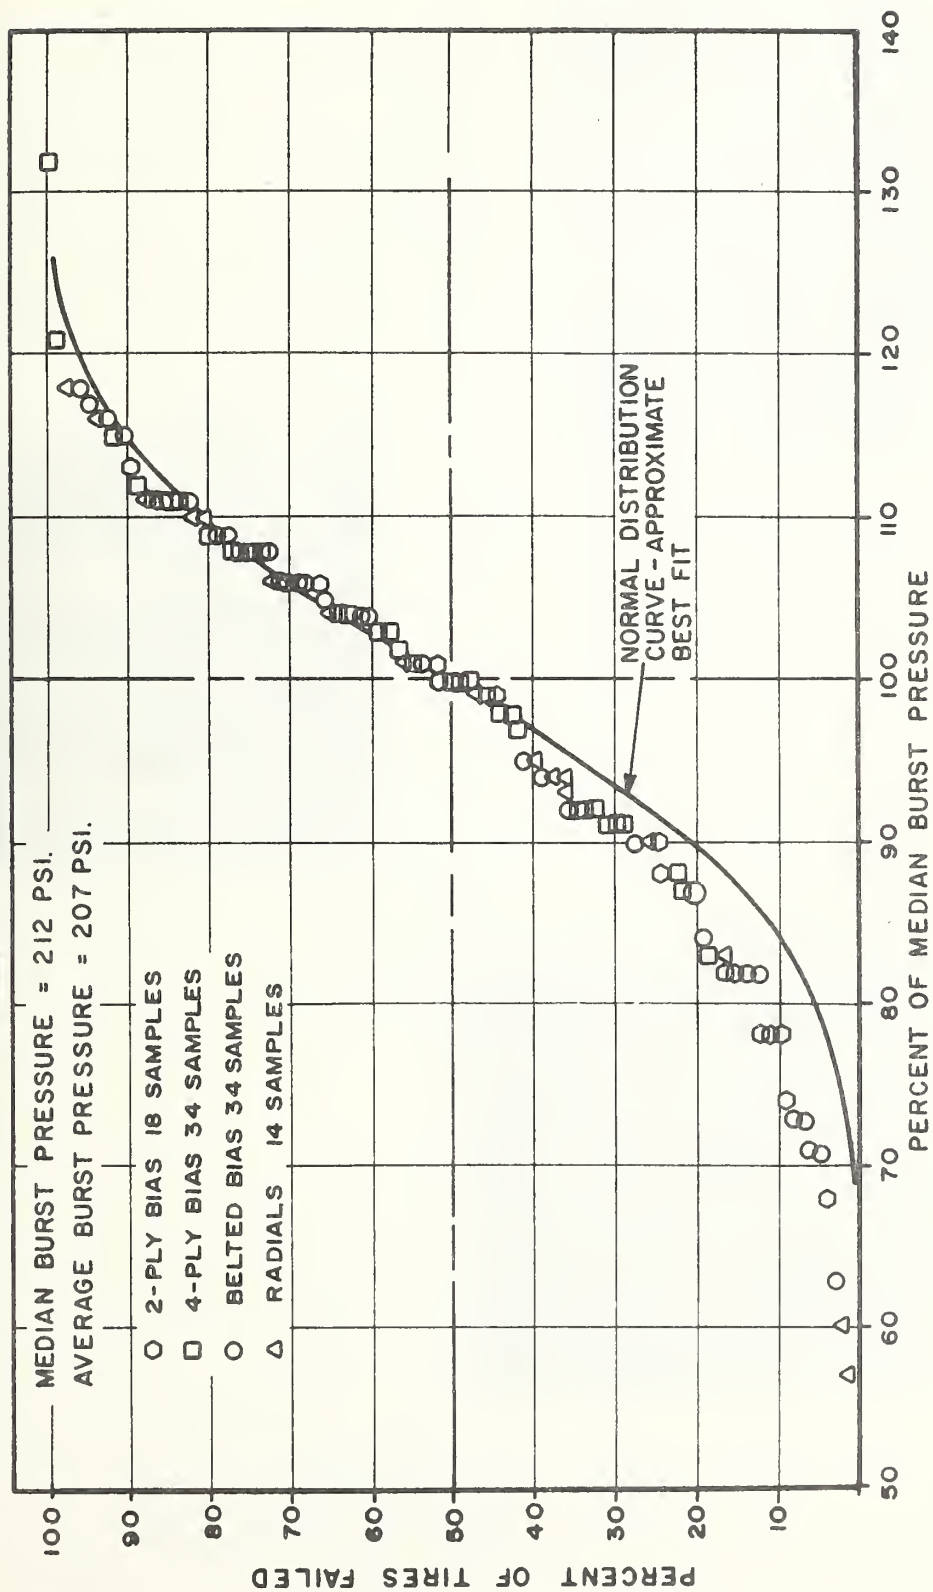
FIGURE 3. PERCENTAGE FAILURE RATE AFTER 100 TESTS

The data of Figure 3 may be compared with a normal distribution curve centered about the 100% of median burst pressure and arbitrarily adjusted to pass through the data point (132% mean burst pressure, 100% failed). This is the uppermost data point shown in Figure 3. It is seen that the data points follow the normal distribution quite well, and if we delete the very low burst pressure data, points probably could be adjusted to fit even better. The low burst pressure points are suspect since the tires causing them may have been damaged in service.

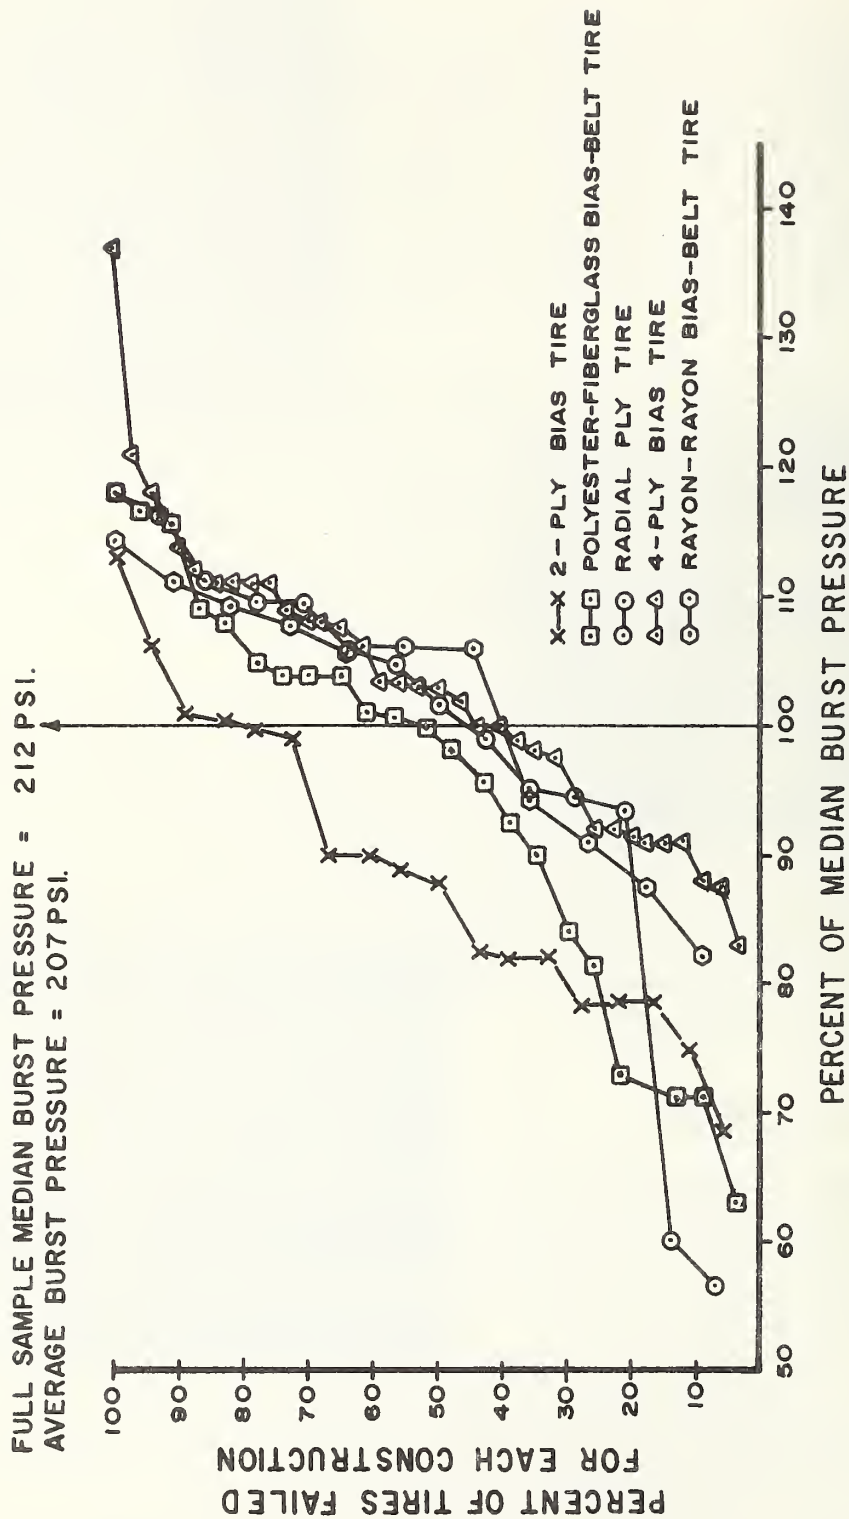
FIGURE 5. PERCENTAGE FAILURE RATE FOR EACH CONSTRUCTION RELATED TO THE FULL SAMPLE MEDIAN

Of final note is the cumulative distribution of failure pressure for each of the construction groups, which are plotted with respect to the full sample median in Figure 5. This graph is of particular importance in the selection of the pressure at which the carcasses are to be proof tested. This graph shows that the selection of a single pressure for all constructions may be prejudicial against certain constructions due to their lower burst pressure. Although there is not adequate data for statistically accurate conclusions, it appears likely that the two-ply bias tires and the polyester-fiberglas bias-belted tires will be penalized by a single pressure value, provided that the proof pressure is chosen high enough to cull out a significant portion of them by burst.

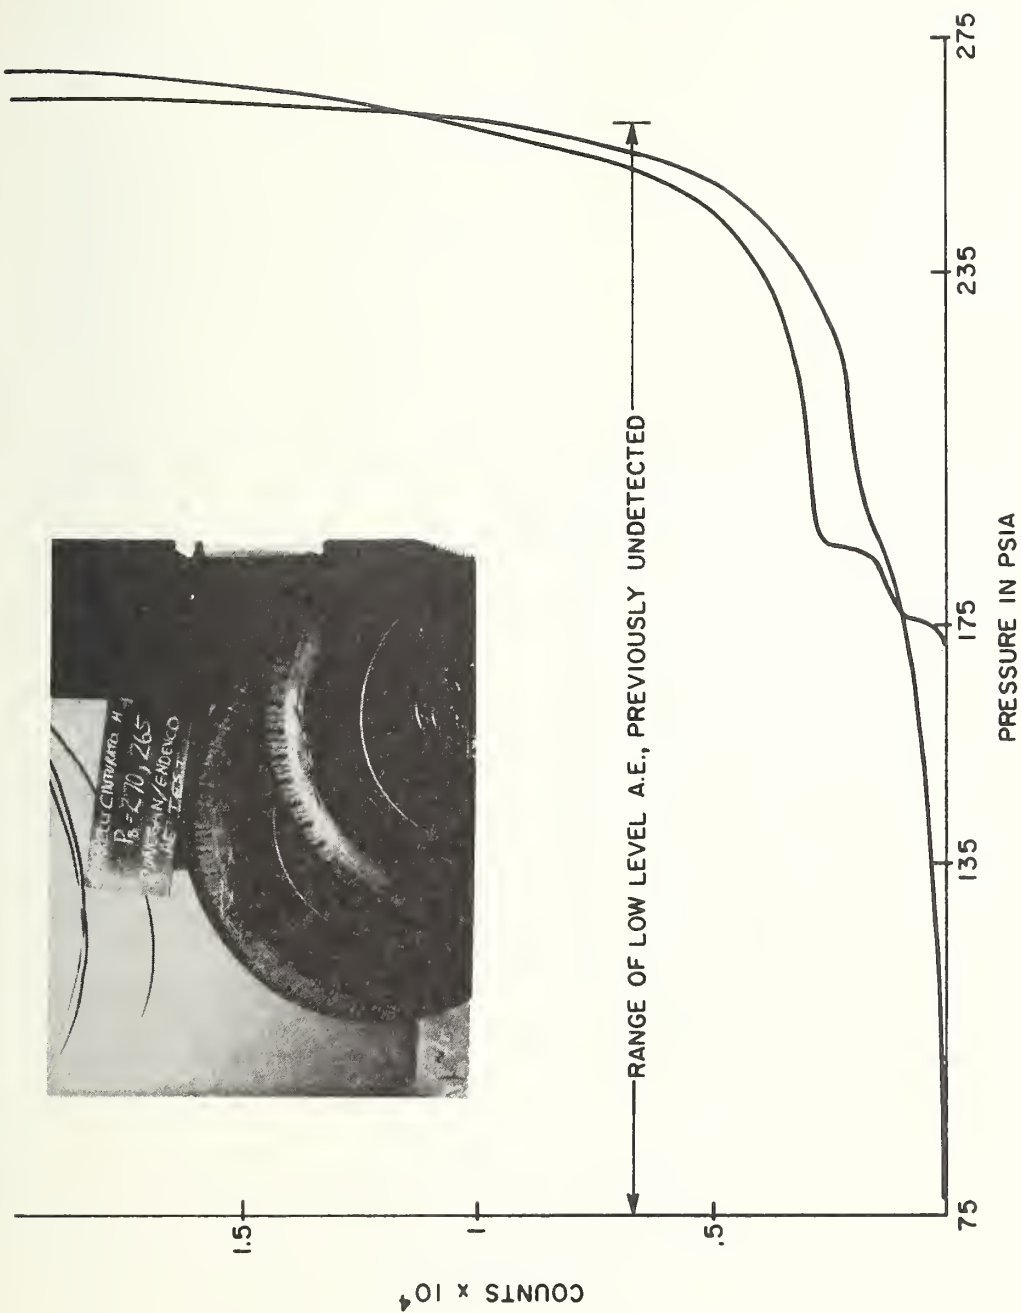
FIGURE 8. ACOUSTIC EMISSIONS VS. PRESSURE LEVEL FOR RAYON-RAYON RADIAL TIRES USING COMMERCIAL ACOUSTIC EMISSION SENSOR

The other pair of tires were of radial ply construction, which had shown characteristically low level emission hardly discernible above the noise level. With the commercial equipment at high gain, curves were produced which exhibited a sharp "knee" just before failure. These are shown in Figure 8. However, it was clear that there were random bursts of A.E. at low pressures and not simply a continuous curve produced by a constant noise level. Note also the similarity of the A.E. curves in Figure 8 and the fact that both tires failed in the sidewall at almost the same pressure.
